Design Note

From: DEMI R&D Dept.
 To: ALL DEM 903,1296, 2304,3456.5760, and 10368 MHz transverter owners
 DN#: 015
 Date: August 15, 2002
 Re: Sudden drop in receive gain

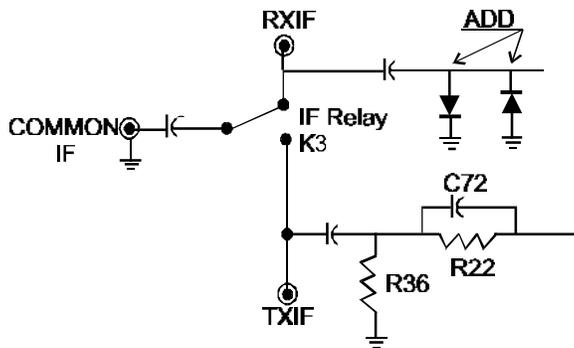
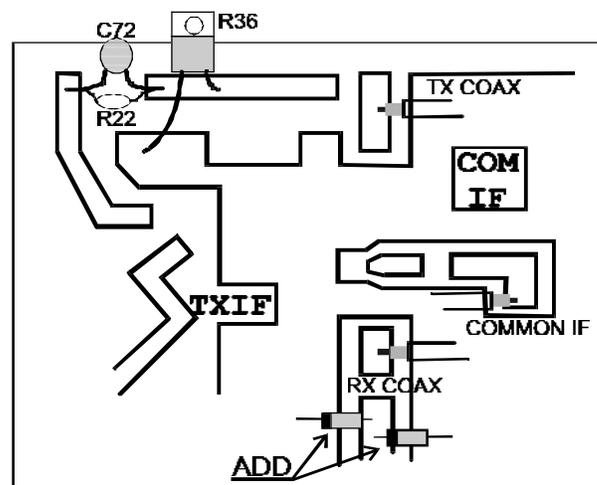
PROBLEM: It has been found that with all of the transverters listed above, kit or assembled, some owners have experienced a sudden drop in receive gain after a transmission. The problem has been isolated to those owners that use 1 watt and above IF drive level. It is caused by a delay of the push-to-talk circuit in the transverter as compared to the transceiver's transmit signal. It is important to understand that when using the PTT output of a transceiver to key a transverter, everything is keyed at the same time. If the relay change in the transverter is still in process when the transmit level of the transceiver comes up, it will send some RF (less than the specified TX drive level) into the receive path of the transverter. This over time may degrade or instantly damage the IF gain stage or the receive mixer if a gain stage is not being used. This problem is more pronounced in the FM mode or if you use full break-in CW.

SOLUTION: Adding two switching diodes (1N914 type) to the RXIF path to ground in the configuration shown below will solve the problem unless the PTT line is not keyed or fails completely. Two fast switching diodes will conduct a certain level of RF energy to ground and only allow non-destructive level to pass to the MMIC or mixer diode. These diodes will not survive a direct hit of 10 watts but this level should never be in the RX path if the PTT line is keyed correctly. Two diodes will only protect the transverter from a slow transfer or double hit of the PTT line. This "Fix" will be included in all kits and assembled units after 7/1/02.
