Design Note

From: DEMI R&D Dept.
To: ALL DEM 2304,3456,5760, and 10368 MHz transverter owners
DN#: 016
Date: September 19, 2002
Re: Low Frequency of Local Oscillators in all Microwave transverters

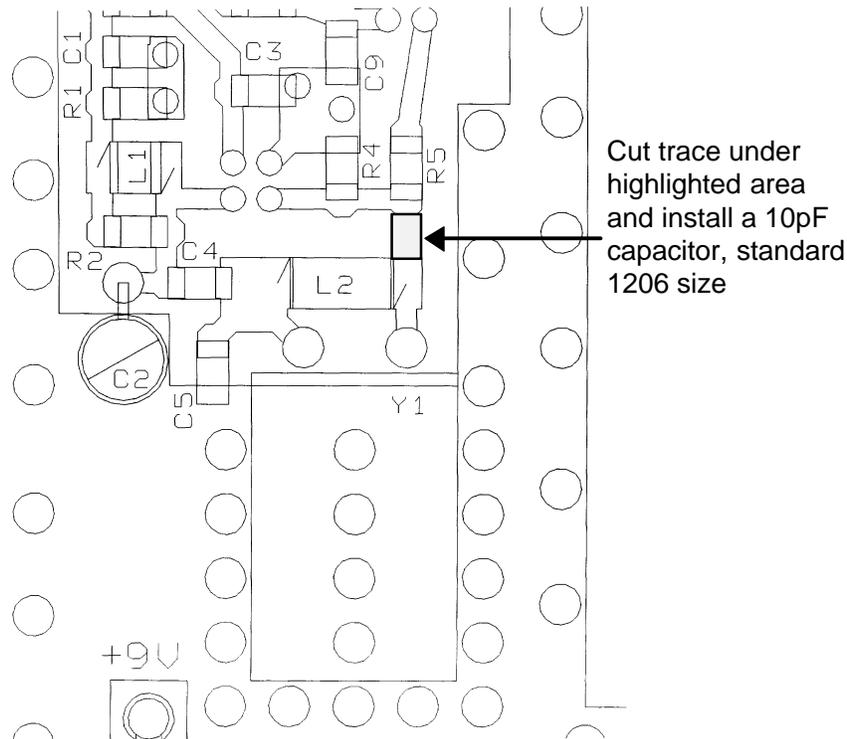
SOLUTION: The solution for a low frequency MICRO-LO is to add some loading capacitance (5-15pF) to the base circuit. It is simple one but does require a circuit modification. To add loading capacitance to the circuit, the crystal and its shunt inductor need to be separated from the original circuit and then attached back to the circuit through a series capacitor. As indicated in the pictorial which is a copy of a segment of the MICRO-LO component placement diagram, you should wick off all excess solder in the area before cutting the trace. This will allow easy use of a razor knife to cut the trace. You may find that removing the L2 inductor (a .1uH molded choke) will provide extra space to cut the trace and install a 1206 chip capacitor. You will need to remove approximately 0.05" of trace to avoid a solder bridge while attaching the capacitor. The chip capacitor quality is not that important. A standard NPO 1206 size chip will be more than adequate. You could use a better quality chip such as a ceramic microwave type with a smaller foot print but it is not necessary. Do not use a leaded capacitor!

After installation, re-start and adjust the MICRO-LO as stated in the MICRO-LO document. You will need to adjust C2 for maximum voltage at the test point and then re-adjust for frequency if required. You should also recheck the frequency of operation after the MICRO-LO is installed in its enclosure and has completely warmed to its operating temperature. Re-adjust as necessary and then check for cold re-start after the LO and/or transverter have completely cooled down.
